Holy Family Catholic Church - a Different Perspective – Maintenance Issues Dominate

Colin Apelt; 26-06-2026

Maintenance of Holy Family Church

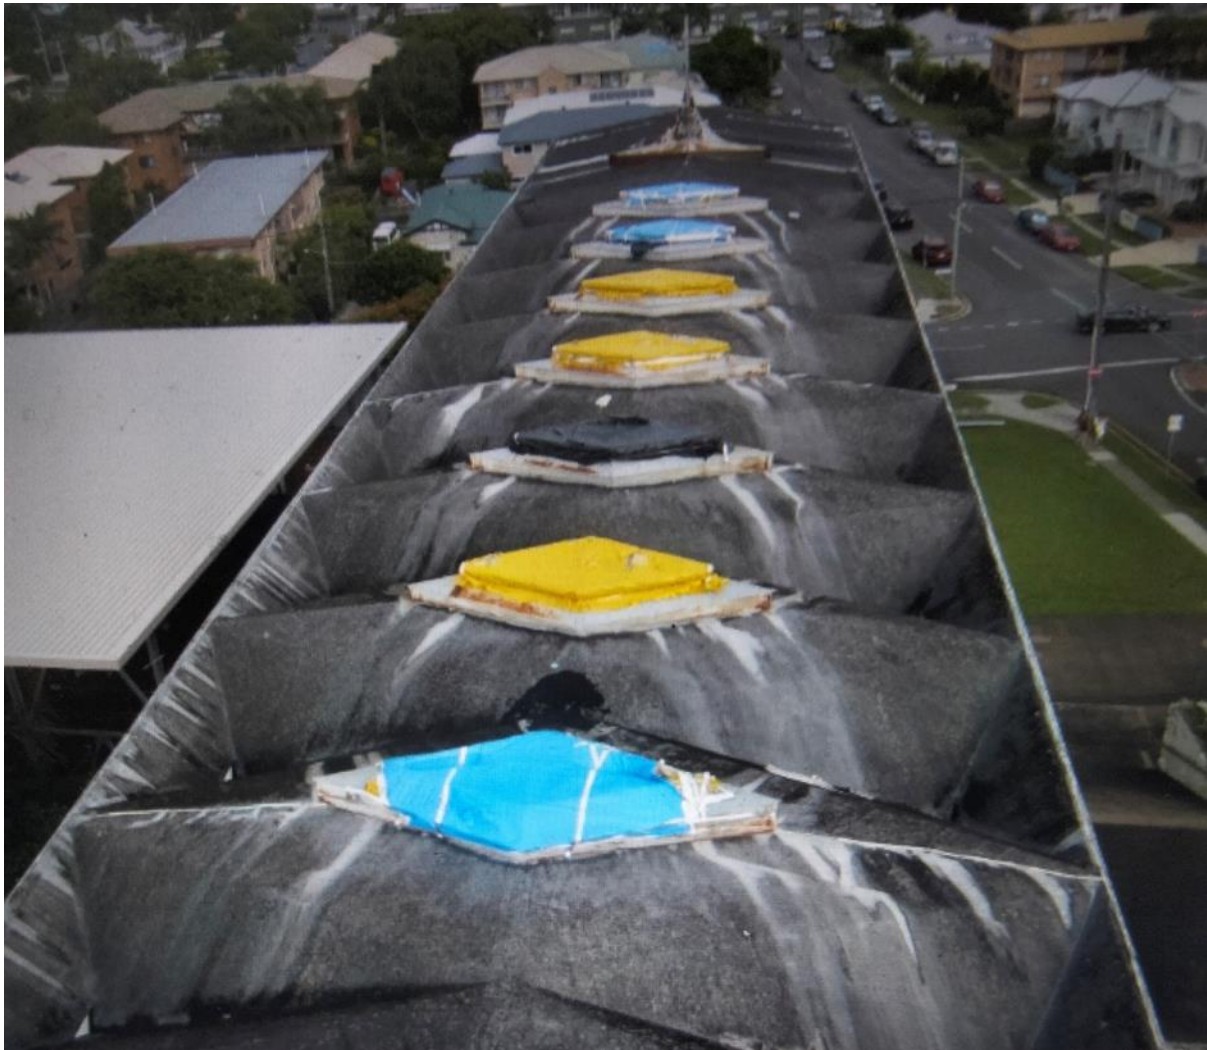
When the church was being designed the Parish Priest, Fr Roberts, was confident that the reinforced concrete roof did not require water proofing – despite expert Engineering advice to the contrary. But the roof leaked badly during heavy rainfall and a water proofing membrane was attached to the roof. This was a bituminous membrane, reinforced with fibres, with the trade name Nuralite. (Tests on a sample from the roof completed in July 2002 reported “Chrysotile Asbestos Detected”.)

Maintenance Stage 1: The membrane covering the roof had deteriorated badly (See Fig 1). During rain, water leaked from many cracks in the roof and the Perlite coating on the ceiling fell on to the pews and floor. Then cockatoos began to strip parts of the membrane from the edges of the roof.

Fig 1 Deteriorated Roof Membrane in 2012

Repair of the roof to eliminate the leakages had the highest priority. Fr Bill Mc Carthy decided to have a steel roof added after rejecting options for replacing the water-proofing membrane. The work for the steel roof was done between late 2013 to early 2014 and was managed by Stuart Lumis, Director of Planning & Building Archdiocese Services (See Figs 2 and 3).

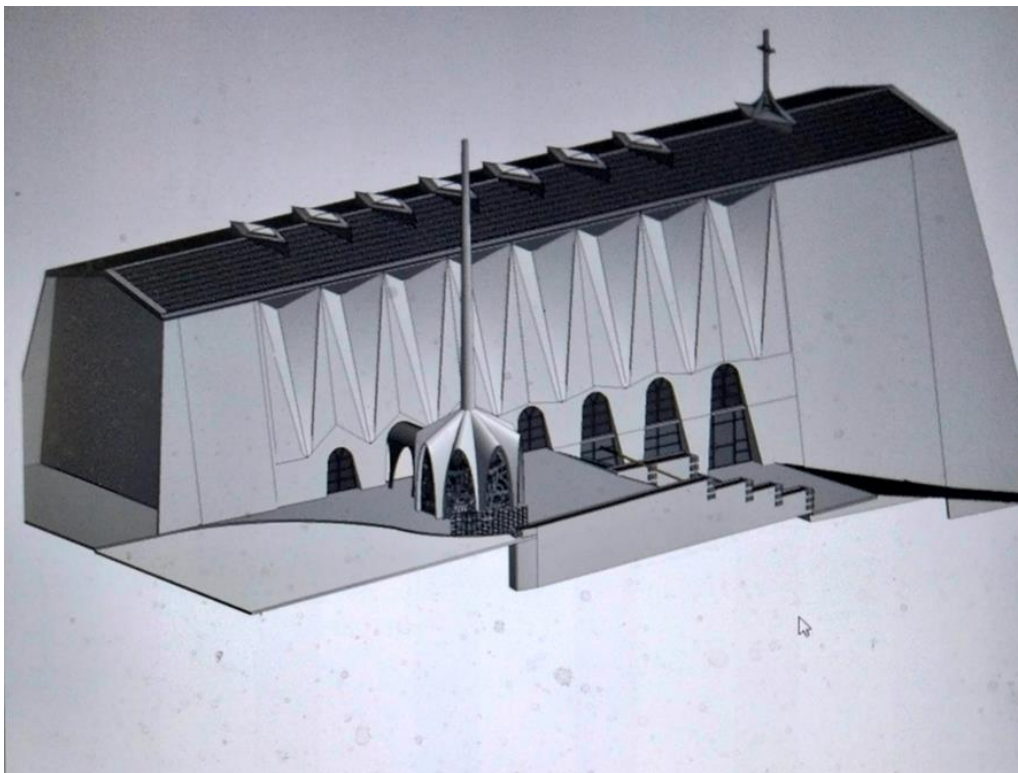
Fig 2 Sketch showing proposed Steel Roof

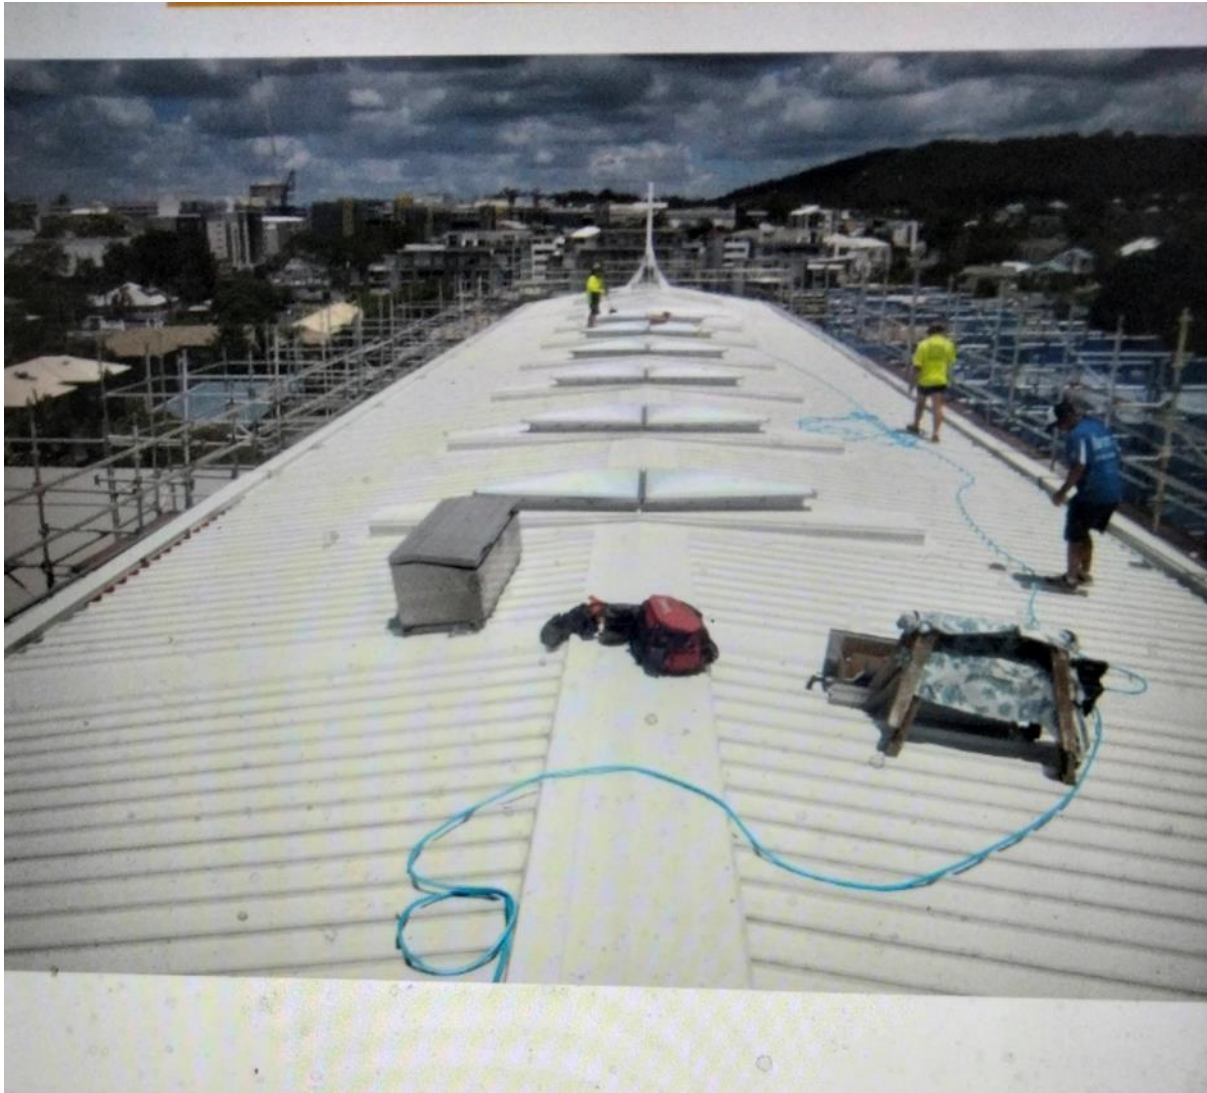
Fig 3 Completed Steel Roof – view towards Central Avenue

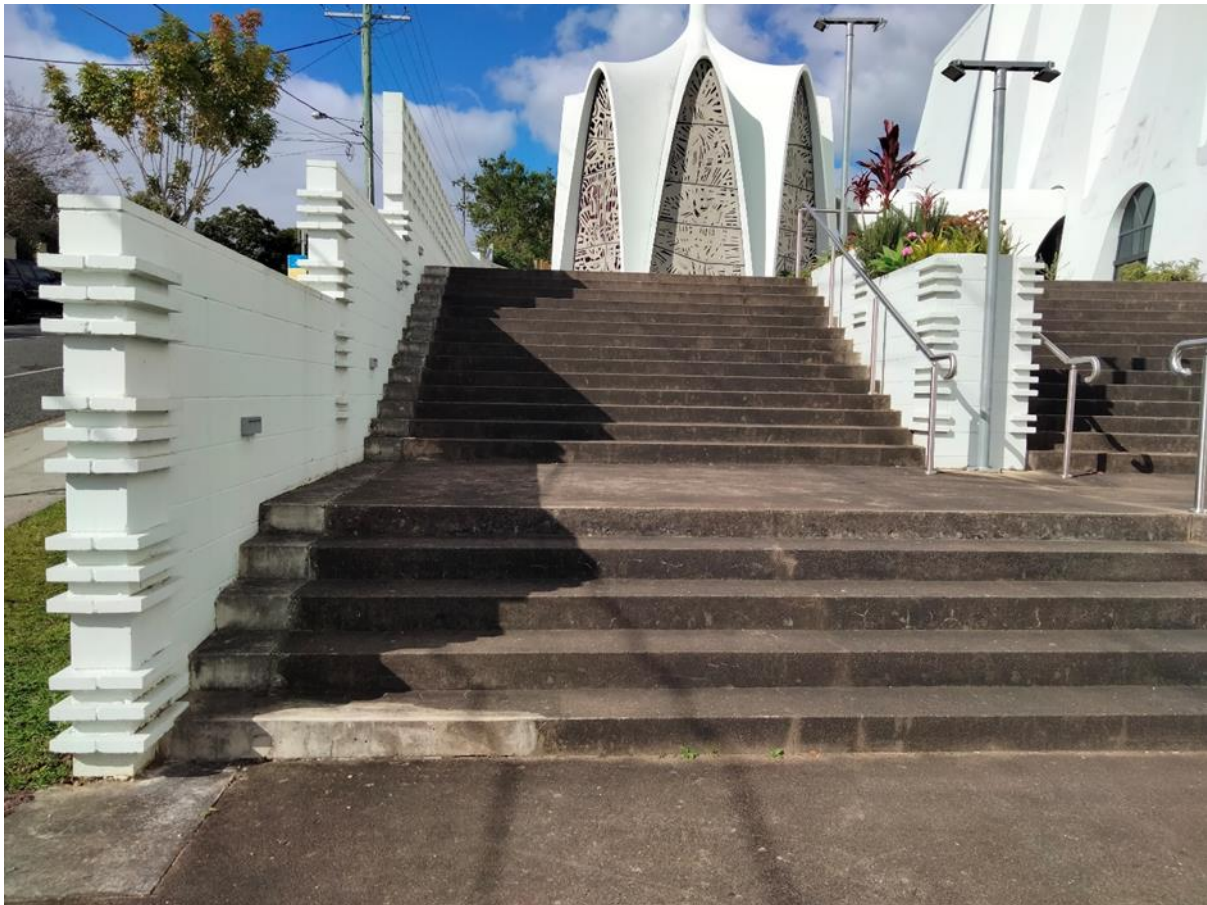
Repair of retaining wall – The retaining wall fronting Ward Street had developed a dangerous lean towards the footpath. The wall was replaced and associated work was done in the stairway, including stepping down of the planting box on the stairway, improved lighting and replacement of the asphalt

Fig 4 New Retaining Wall, Central Garden and Lighting

at the entrance to the Church with concrete. Extra blockwork was added to the top of the wall to satisfy safety requirements (See Fig 4). This work was done from late 2019 to early 2020.
